**BROWN DAM
NJ 00117**

**PHASE 1 INSPECTION REPORT
NATIONAL DAM SAFETY PROGRAM**

BROWN DAM (NJ00117)

PHASE I REPORT
NATIONAL DAM INSPECTION PROGRAM

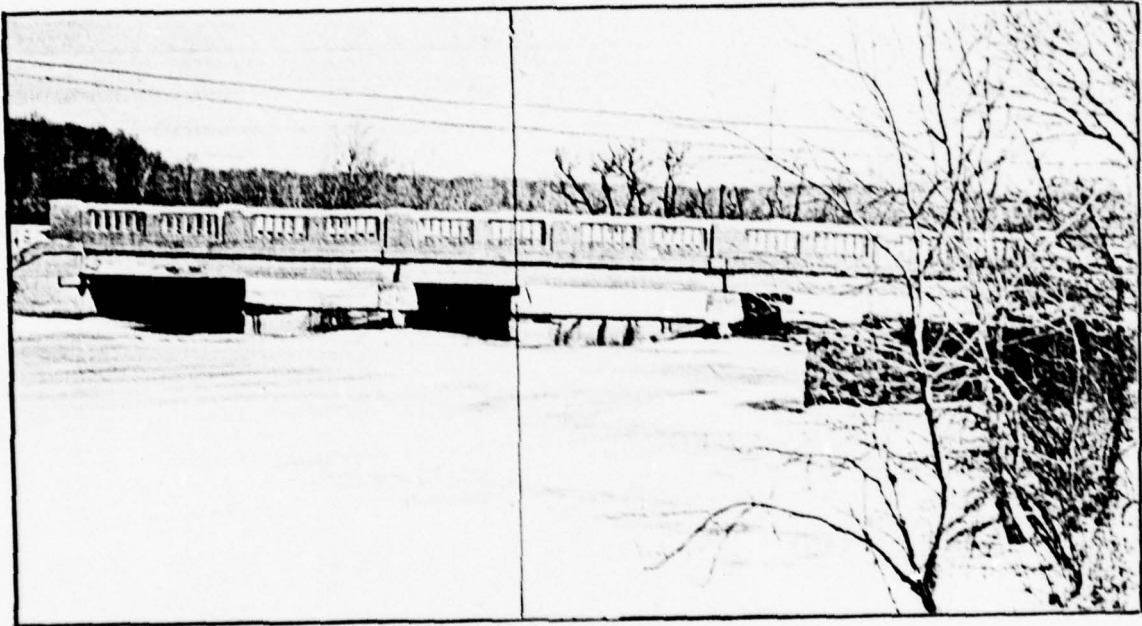
County bridge near right abutment

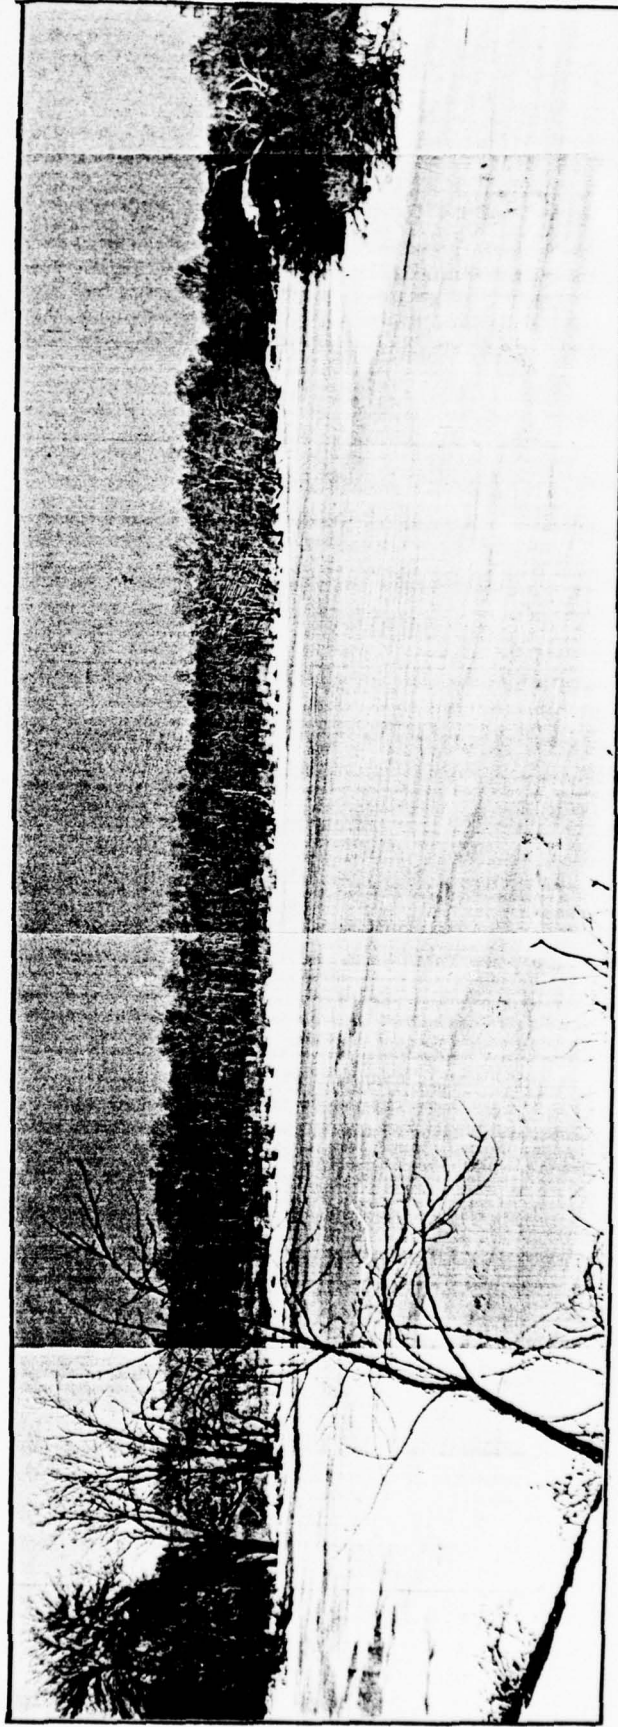
View upstream from dam

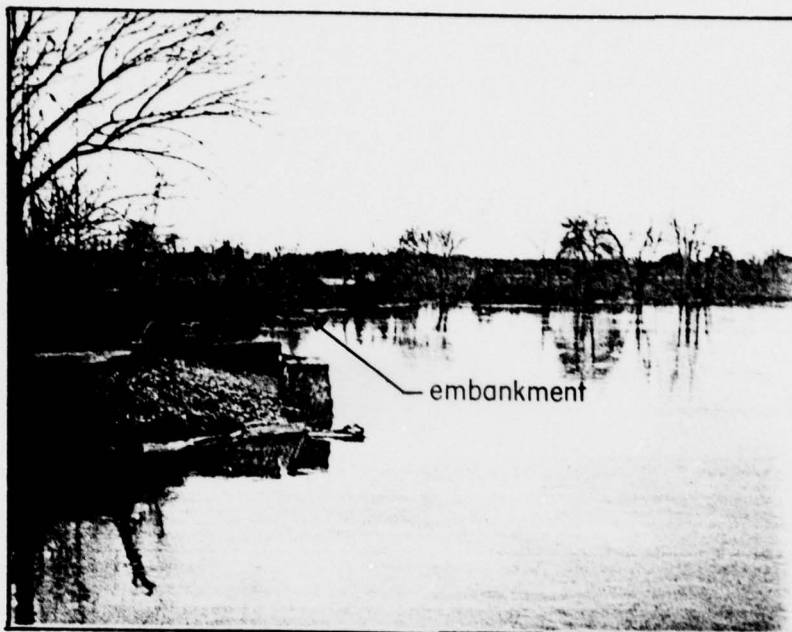
East end of dam

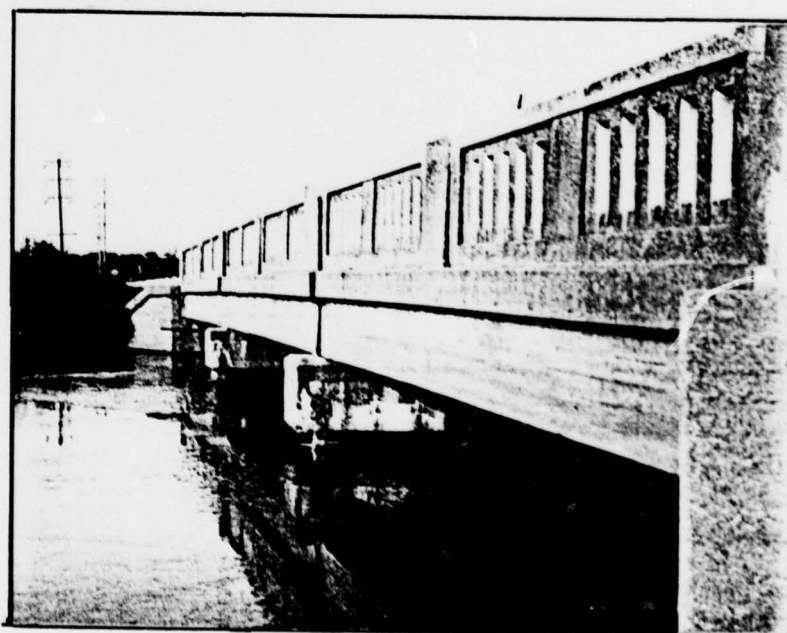
County bridge over Salem River at East end of dam

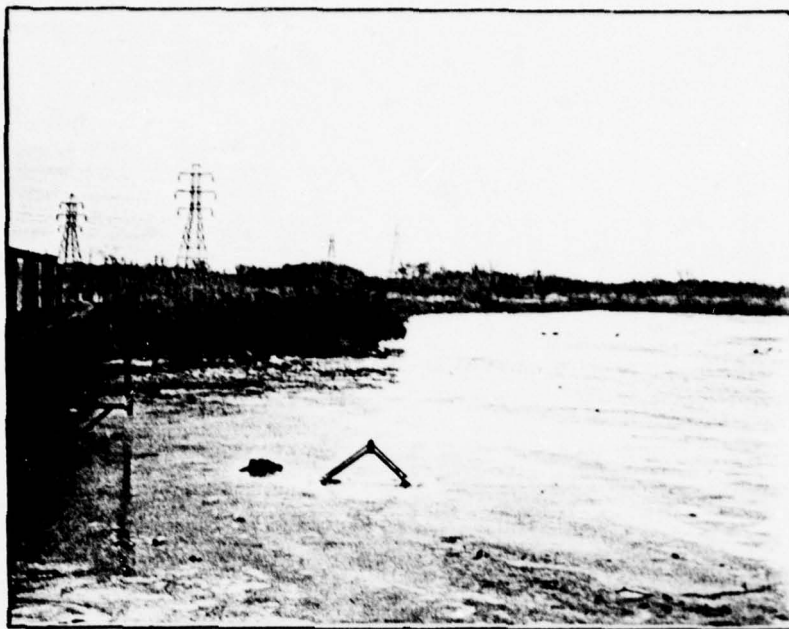
View East along dam

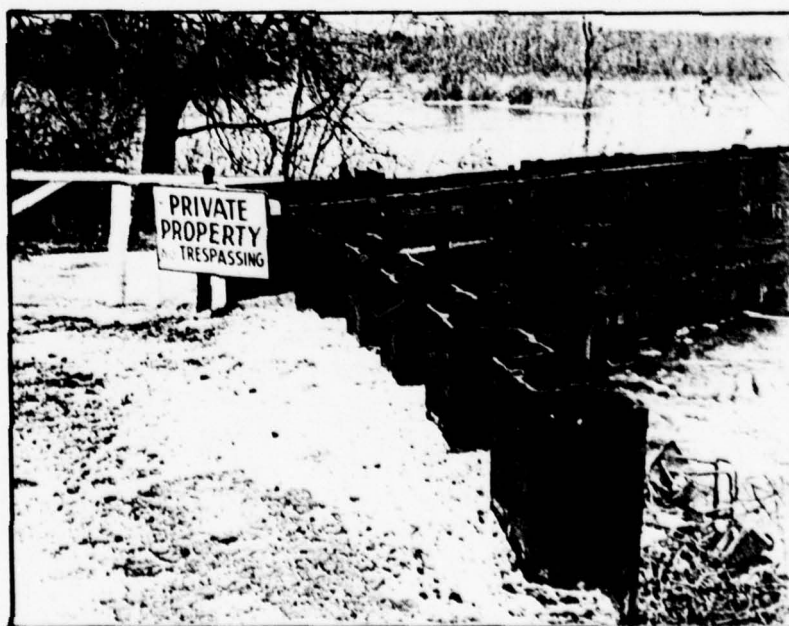
Although the main structural elements of Brown Dam are 45 years old, it is in a good overall condition reflecting the continued high caliber of maintenance. Although little except the top portions were visible, the steel sheeting is in true alignment and the exposed surfaces show little evidence of excessive oxidation, indicating a good grade of marine structural steel. The exposed concrete within the spillway is in a satisfactory condition as is the catwalk. The dam embankment crest roadway is at true grade with only minor cracking evidenced.

Steel sheeting at left spillway abutment

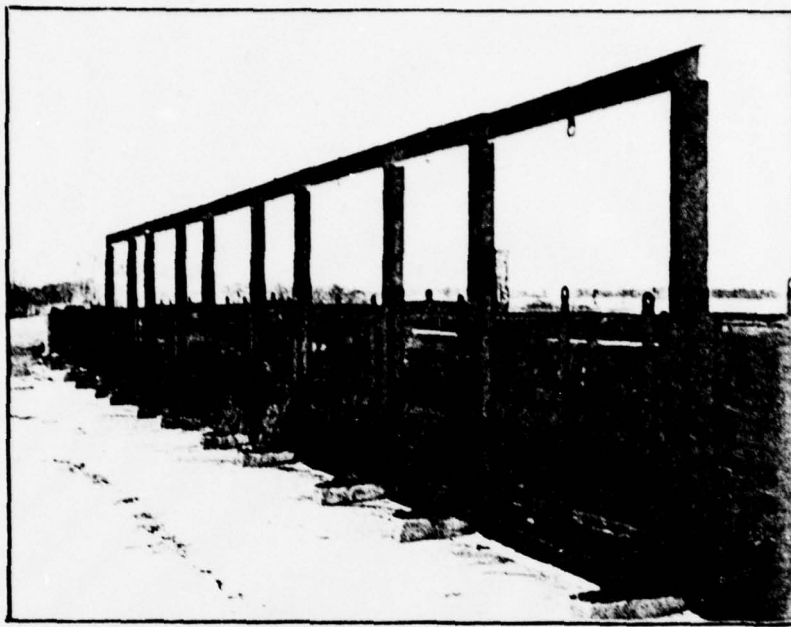
Hoist brackets for flashboards

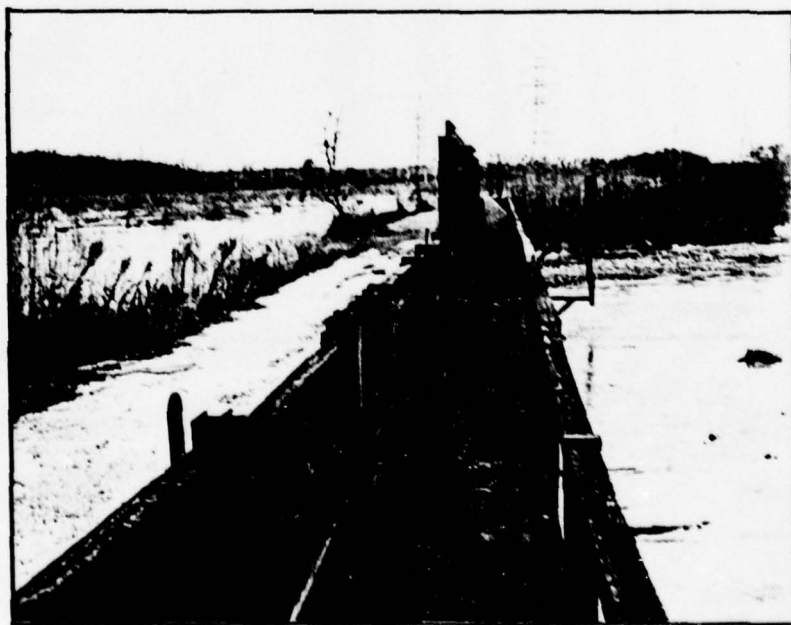
View East along catwalk
